## Iveco Daily Modelljahr 2017-2018 mit Lenkradfernbedienung und *ohne* Radio

## Iveco Daily model year 2017-2018 with steering wheel remote control and without Radio

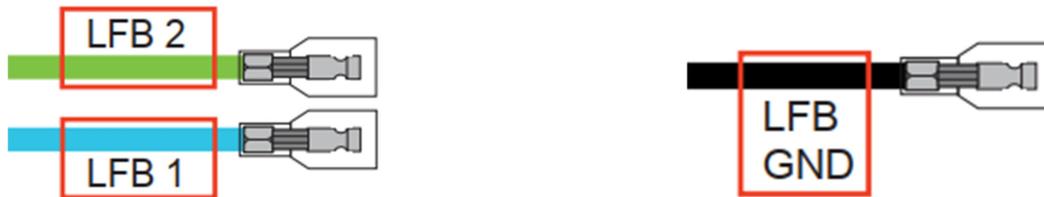
Kabelstrang für Lenkradfernbedienung:

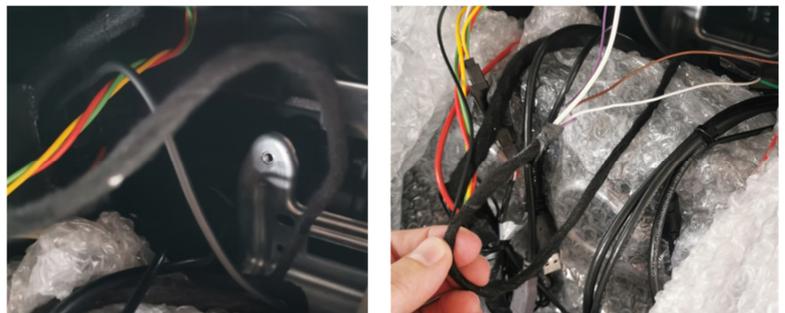
Im Radioschacht befinden sich lose Kabel die zusammen getaped sind.  
Diese beinhalten zwei rosa Kabel und ein braunes Kabel.

Das braune Kabel mit LFB GND verbinden.  
Das rosa Kabel, welches die Nummer **9020** trägt muss mit LFB 1 verbunden werden.  
Das rosa Kabel, welches die Nummer **9021** trägt muss mit LFB 2 verbunden werden.

**Sollten die Lenkradtasten nicht richtig funktionieren, müssen die Kabel LFB 1 und LFB 2 vertauscht werden.**

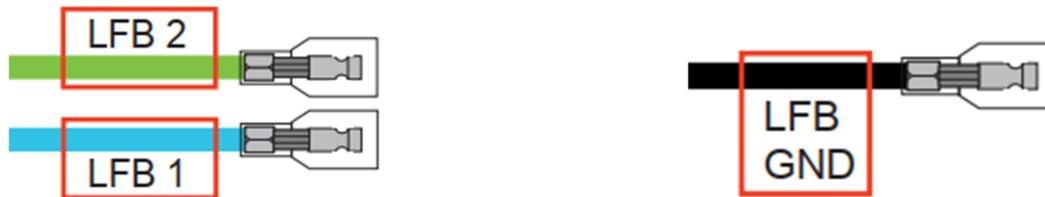
Wiring harness for steering wheel remote control:

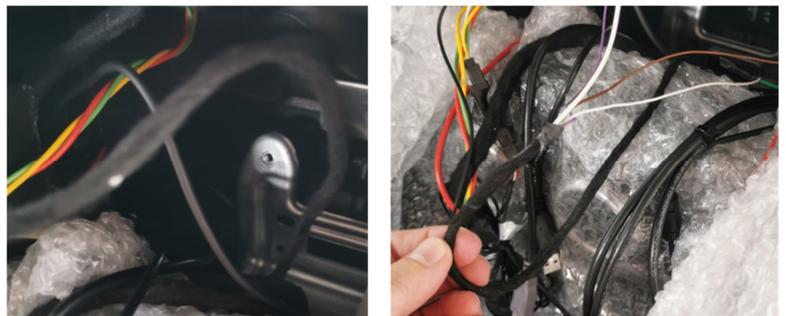
There are loose cables in the radio slot that are taped together. These include two pink wires and a brown wire.

Connect the brown wire to LFB GND.  
The pink wire showing the number **9020** has to be connected to LFB 1.  
The pink wire showing the number **9021** has to be connected to LFB 2.

**If the steering wheel buttons do not work properly, the cables LFB 1 and LFB 2 have to be swapped.**
